Fire Restoration Cleaning

Technical Bulletin 0100

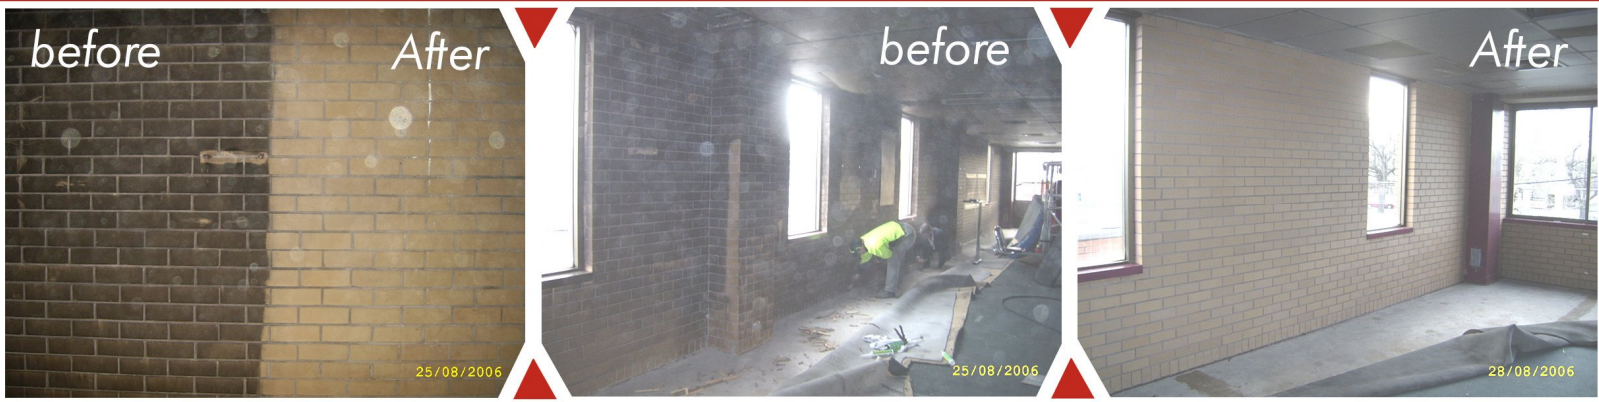
Vandals broke into this multipurpose Gym in Lilydale, Victoria and on leaving, decided to set fire to the premises, causing widespread damage throughout the main room, toilets and kitchen areas. The size of the area that was affected was some 250+ square meters. From the main reception area where the fire was started, deep black carbon had spread to all corners of the room. Loss of Profits Insurance ensured The Graffiti Eaters were called in quickly to quote the job and work started that very day.

3000 liters of water was required to neutralise and remove the carbon and a water waste management plan was put in place to collect and expel the water. Through our experience with internal fire damage and preparation work, water caused no damage to any other parts of the property. The owners of the shops below were very impressed and all a concern was relieved.

Within 3 days, the building walls were restored back to their original condition. All of the carbon was chemically neutralised to ensure the environment was not left acidic in pH.
